# The Impact of Radiative Heat Flux from Building Fires on Insurer Certified PIR sandwich panels.

Mostyn Bullock BEng CEng FIFireE

# Investigation of performance in real fires

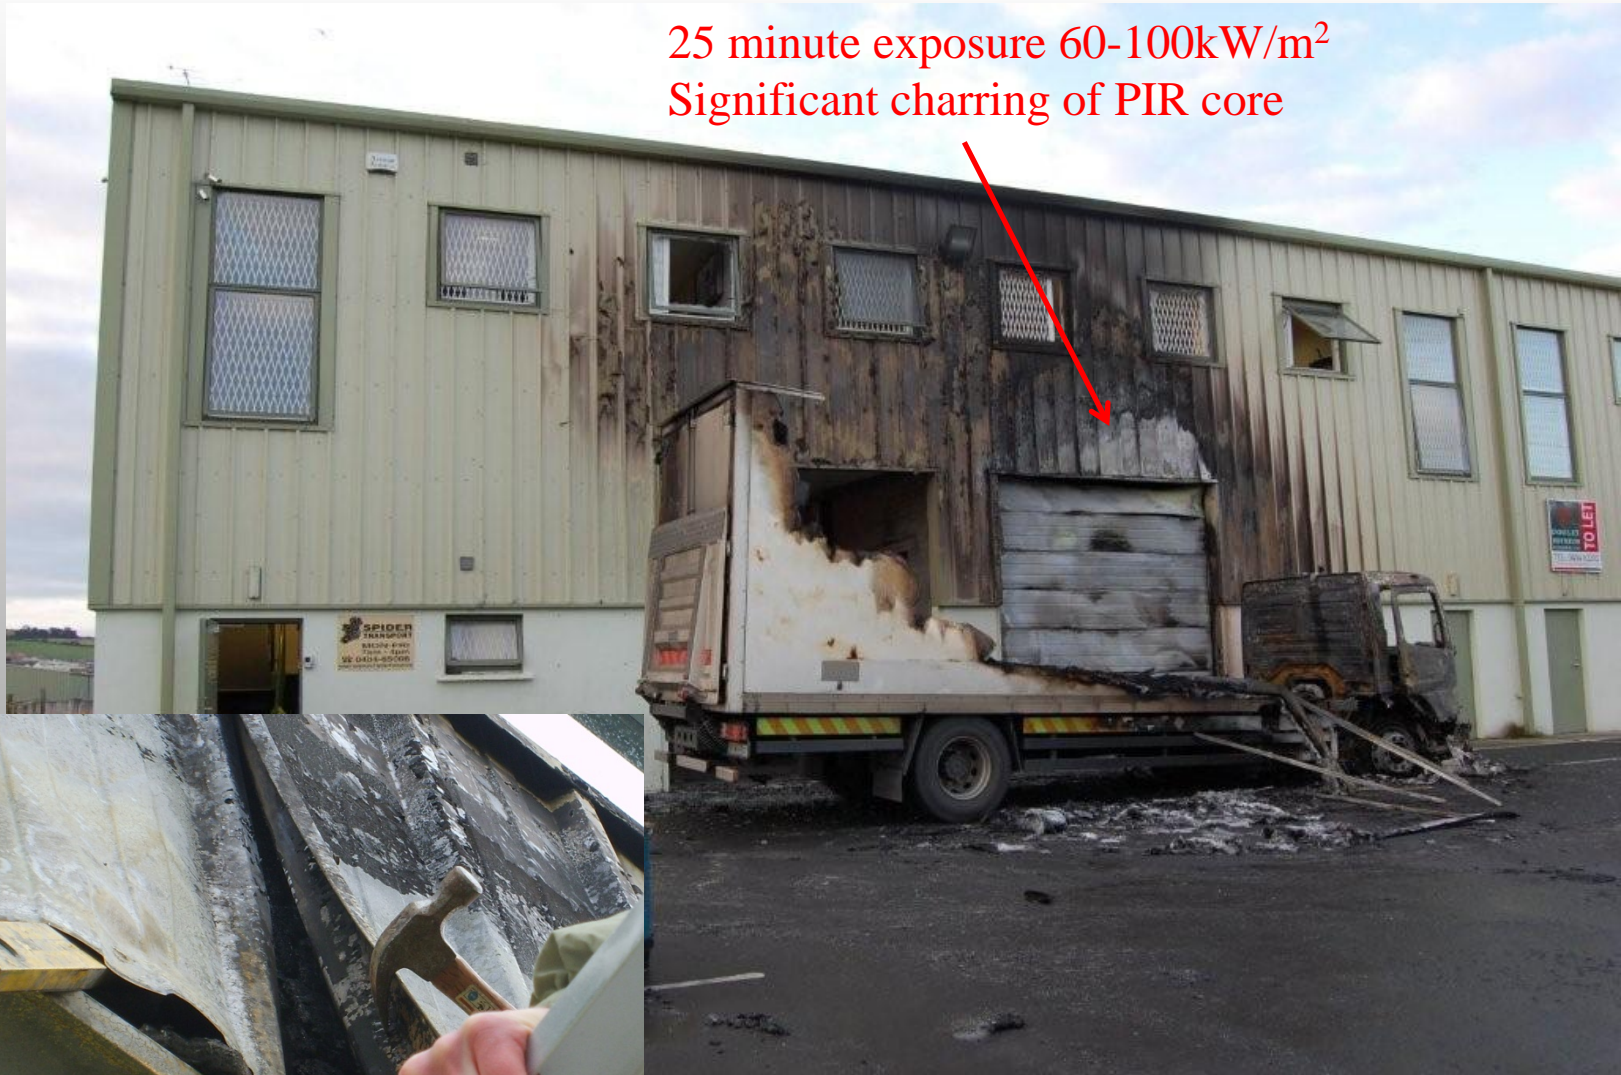
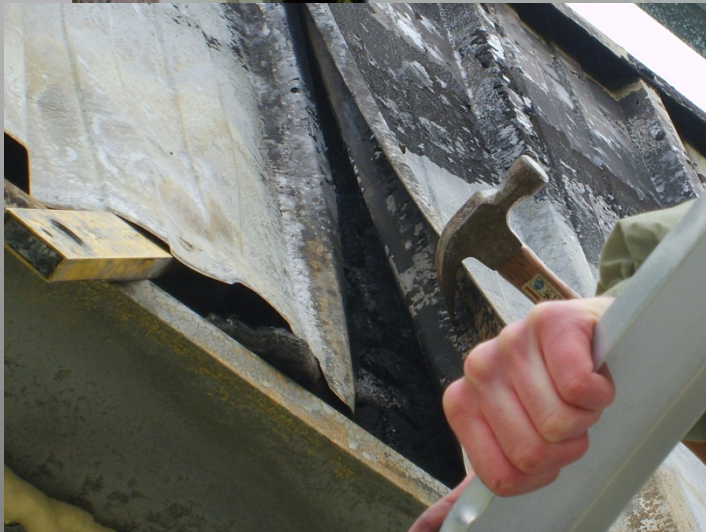
# Spider Transport, Ireland - 2008

25 minute exposure 60-100kW/m<sup>2</sup>  
Significant charring of PIR core

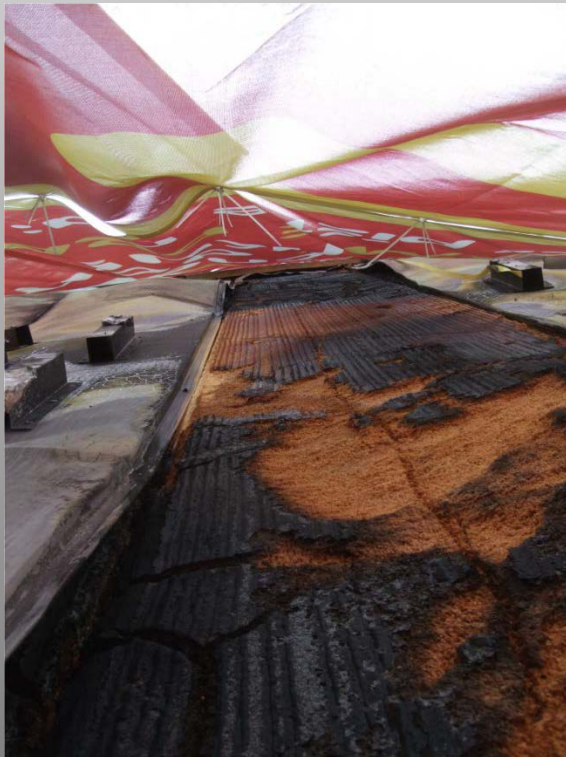
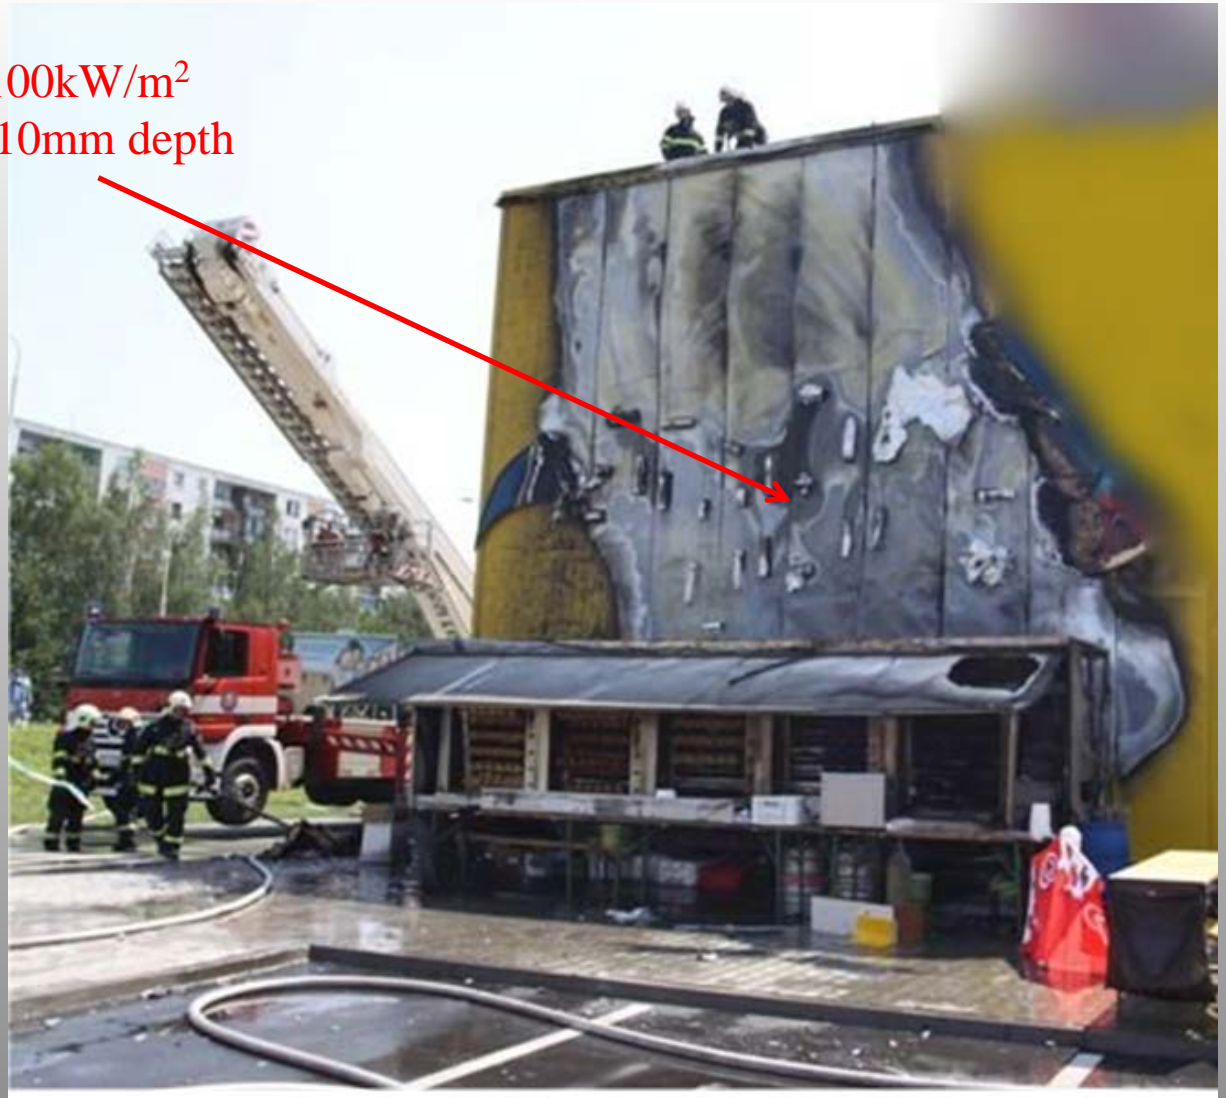
# Furniture Store Slovakia - 2012

10 minute exposure 60-100kW/m<sup>2</sup>  
Charring of PIR core to 10mm depth

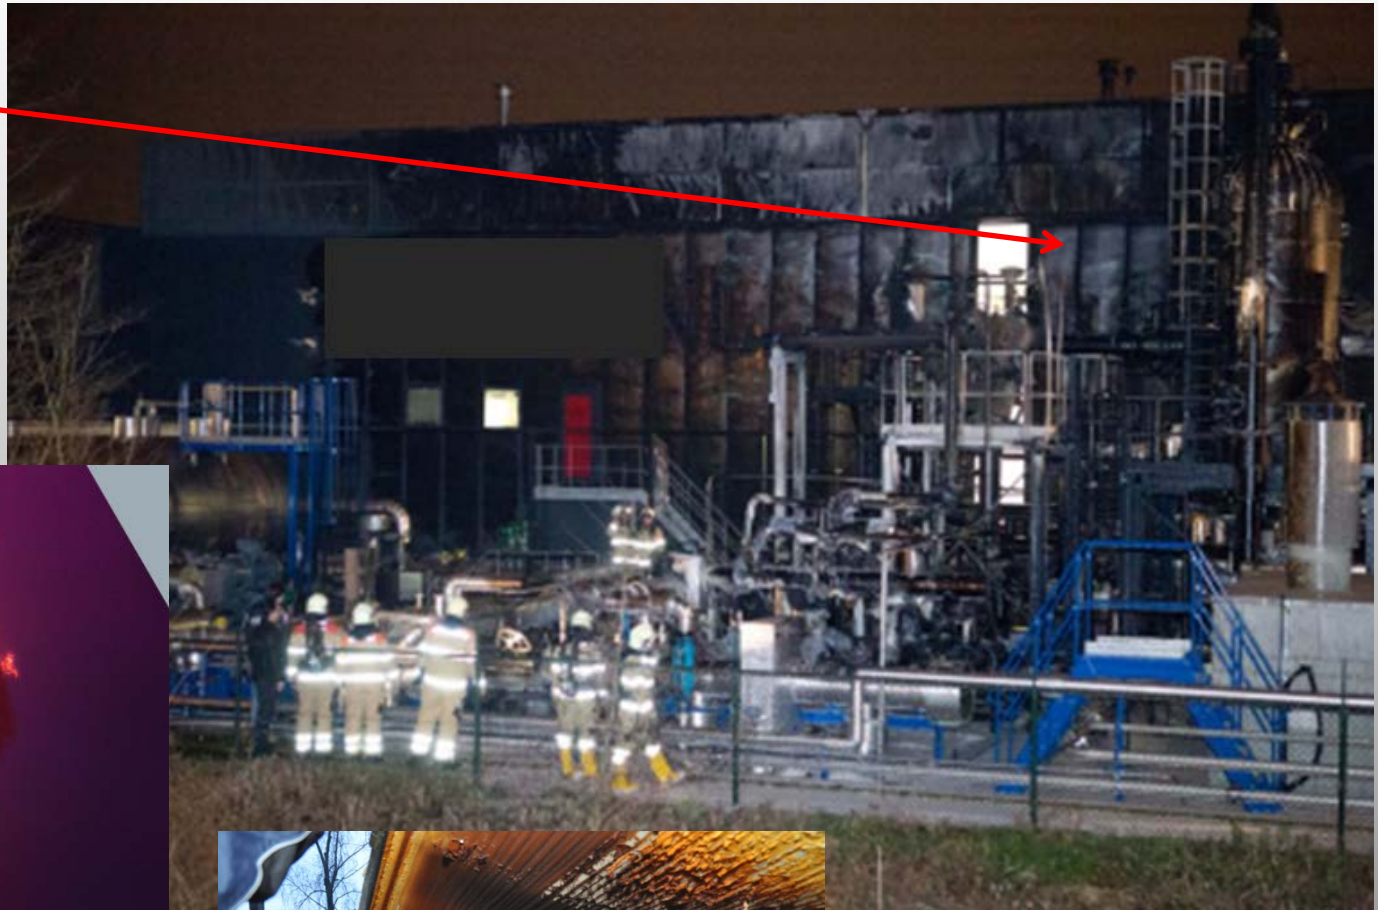
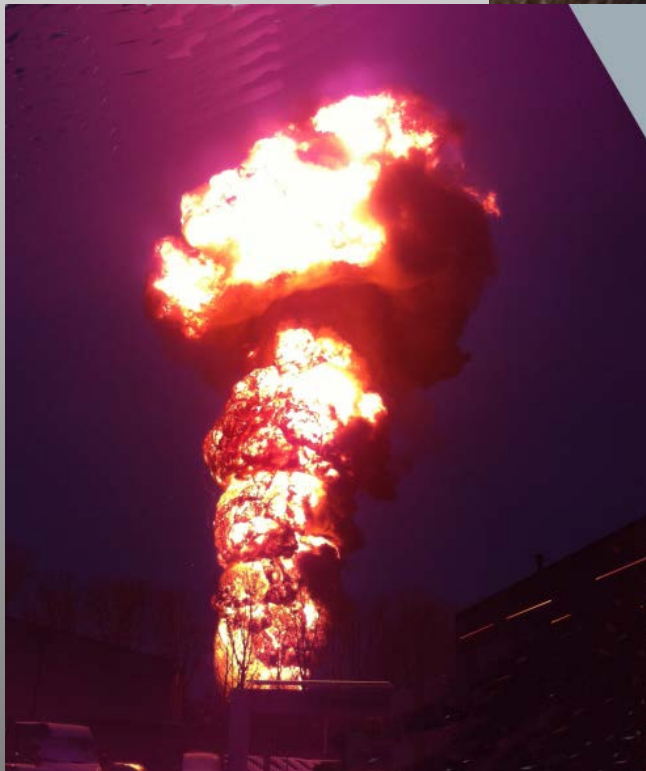
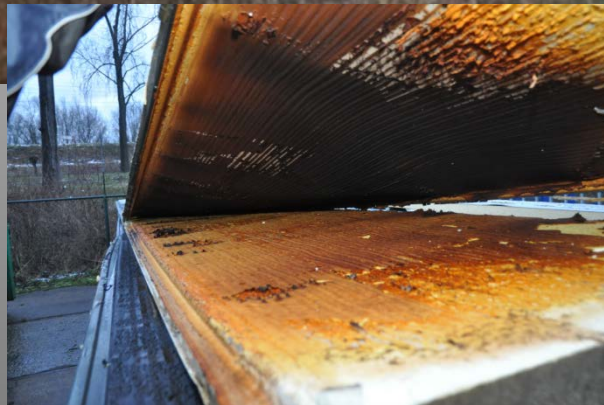
# Oil facility, Netherlands - 2013

8 minute exposure  
24kW/m<sup>2</sup>  
Surface charring of  
PIR core

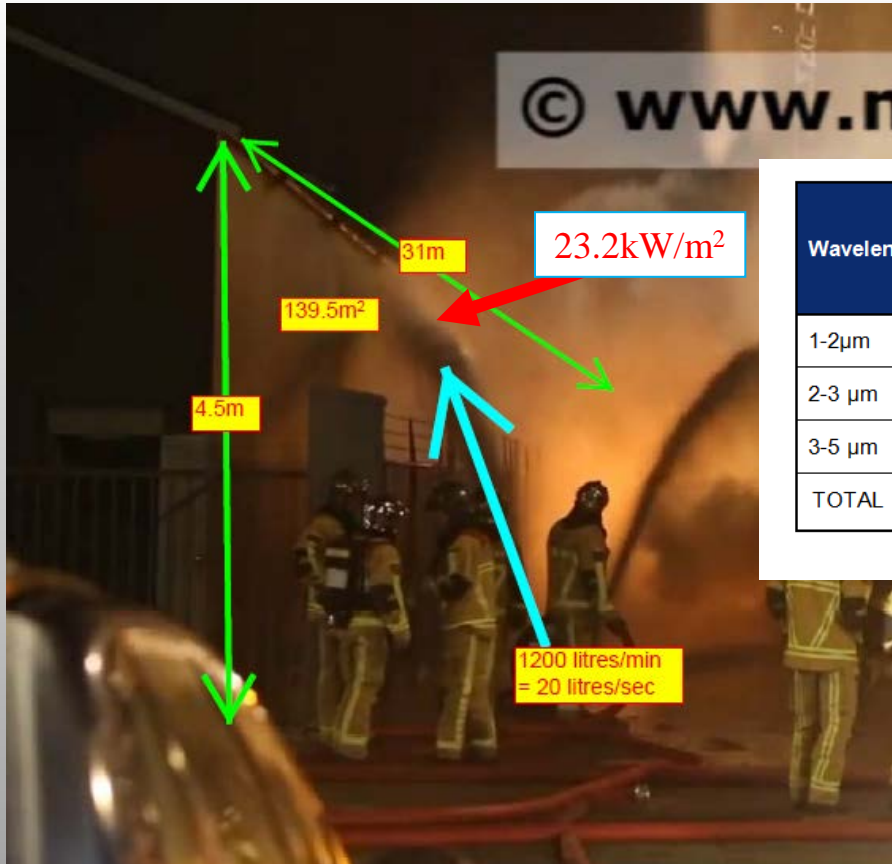
# Heining, Netherlands - 2013

Assume water film spread evenly over wall surface = 0.0143mm/sec applied

Wavelength	Relative % of R <sub>e</sub>	Incident heat flux at this wavelength range, kW/m <sup>2</sup>	Absorption coefficient, cm <sup>-1</sup>	Residual Heat Flux at water/surface interface, kW/m <sup>2</sup>
1-2µm	25.2	5.85	1	5.07
2-3 µm	34.7	8.05	100	1.93
3-5 µm	40.1	9.30	1000	5.7 x 10 <sup>-6</sup>
TOTAL Incident Heat Flux		23.2	TOTAL Residual Heat Flux 7.0

Based on 4.5m wall height the flow time from top of wall to ground = 1 second (approx).

In this 1 second the water film absorbs:  
 $23.2 - 7.0 = 16.2\text{KJ/m}^2$

Based on specific heat capacity of water:  
 Temp rise = 27°C

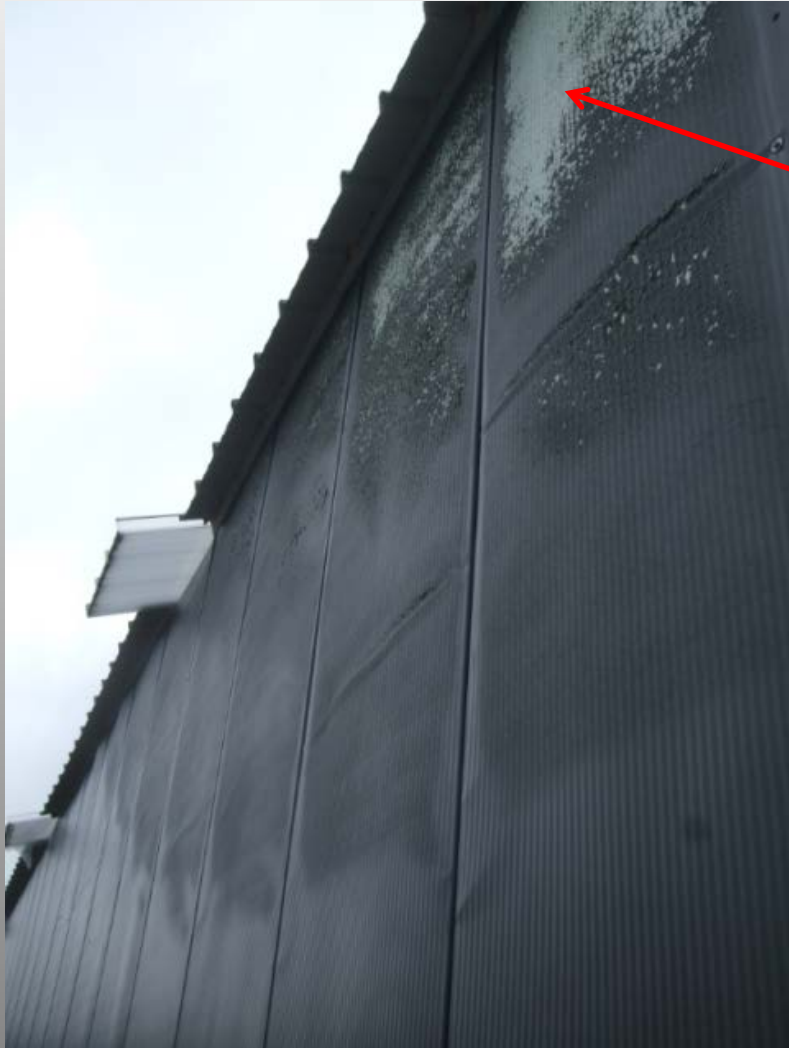
# Heining, Netherlands - 2013

15 minute exposure ?  
17kW/m<sup>2</sup> ?  
Charring of PIR core?  
(yet to be dismantled & inspected)

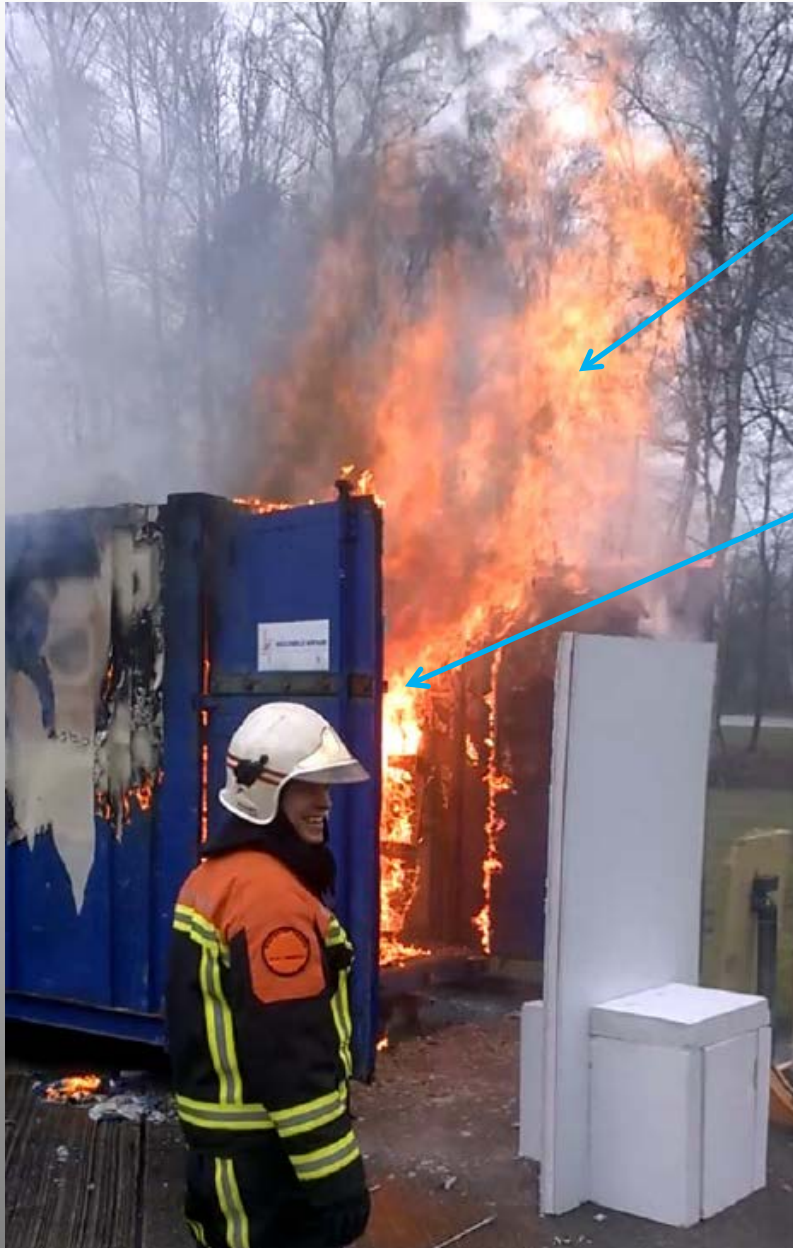
# Troned – March 2014

Plume:

Emissivity = 0.423

Heat Flux emitted = 34.5kW/m<sup>2</sup>

Opening:

Emissivity = 1.0

Heat Flux emitted = 84kW/m<sup>2</sup>
